Gap and Flush Automotive Interior

Inspection Problem

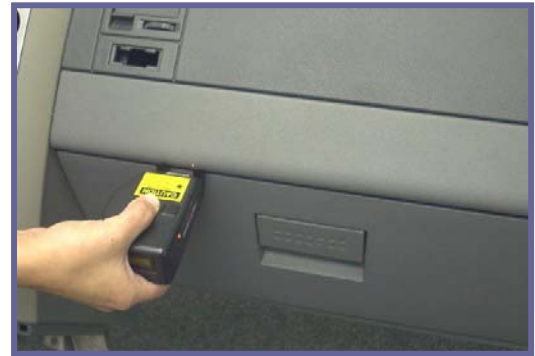
Interior components of a vehicle, such as the instrument panel and trim, are inspected for fit by the manufacturer and inspected after they are assembled in vehicles. Measuring gap and flush on these parts is difficult because of the unusual surface contours and nominally small gaps. Mechanical tools are almost impossible to use because of the flowing contours and the small to non-existent gaps. Manual tools like feeler gauges depend too much on the operator's individual abilities.

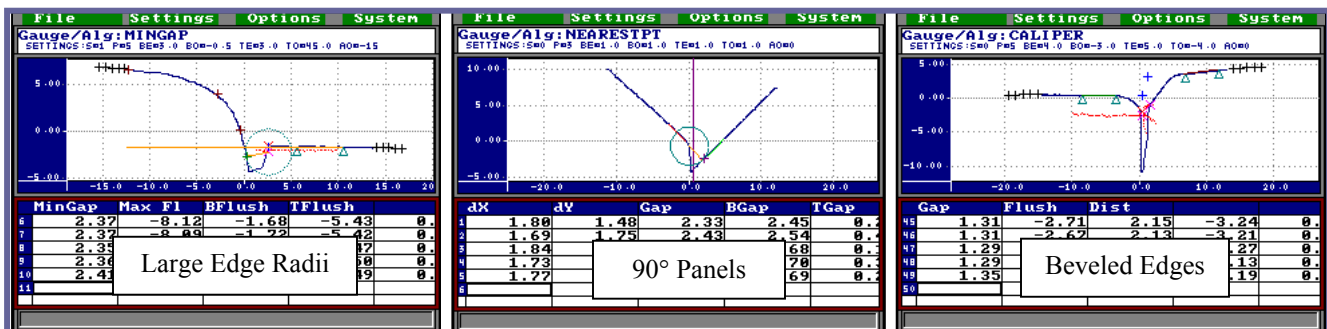
Measurements - Flexible Virtual Gauges allow features to be measured according to a number of different methodologies. Once each point's appropriate methodology is identified, it is incorporated in the inspection routine and runs automatically when the point is inspected.
