How to Inspect FOD on Exterior Airframes

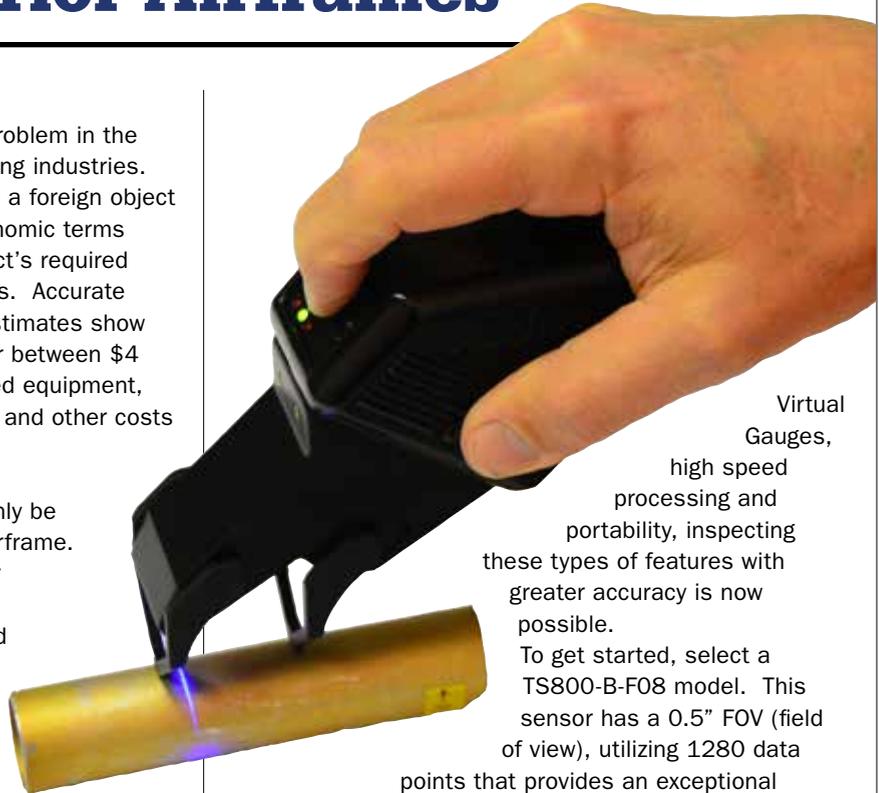
Prevention of FOD is the basic strategy for avoiding associated cost of rework. However, in instances where FOD has occurred, Origin Technologies Corporation has the features in its LaserGauge TS800 with Blue Laser Technology to inspect and measure scratches, nicks, dents, gouges, pitting, corrosion, abrasions, wear, fretting, scratches, burrs, etc., which may be detrimental to the function and integrity of the part or assembly. This Blue Laser Technology allows exceptional measurements to be taken due to a sharper laser that provides finer detail, fewer reflection issues from surface material and reduced scanning noise. Coupled with Origin's accurate

Virtual Gauges, high speed processing and portability, inspecting these types of features with greater accuracy is now possible.

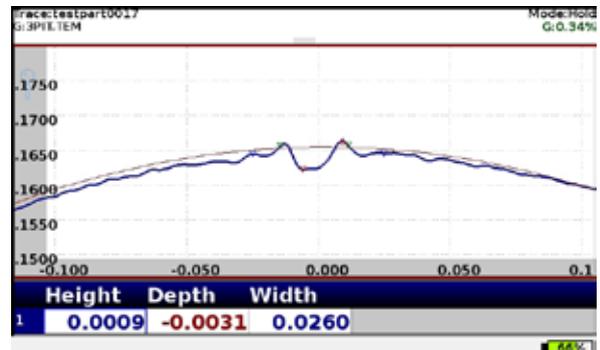
To get started, select a TS800-B-F08 model. This sensor has a 0.5" FOV (field of view), utilizing 1280 data points that provides an exceptional depth accuracy of +/-0.0005" (13µm) and a horizontal scanning resolution of 0.0004" (10µm). Sensor features that allow even the smallest abrasion to be measured. And not just on flat surfaces. FOD on tubes, pipes and other surfaces with complex curves or features lines may be measured to determine how much material has been removed, and thus, how much of the original surface or wall is remaining. Depth micrometres and other mechanical devices cannot provide meaningful measurements because of the contour of the surfaces and the small features that have to be measured.

Simply hold the palm sized sensor so the standoffs straddle the surface feature you want to inspect and press the trigger. As the blue laser strikes the surface feature, high resolution optics take an image. High speed processors analyze the image and advance algorithms are then applied to extract the numerical data. Results are displayed in both visual 2d scans or profiles in addition to numerical data in a table. Measurements take less than one second! Values can even be color-coded to indicate in-spec and out-of-spec conditions for immediate feedback to determine next step in rework process.
